# FORUM

NEW SERIES Volume 6 2017

# The Journal of Council for British Archaeology YORKSHIRE

CBA Yorkshire Annual Review Research, Fieldwork and

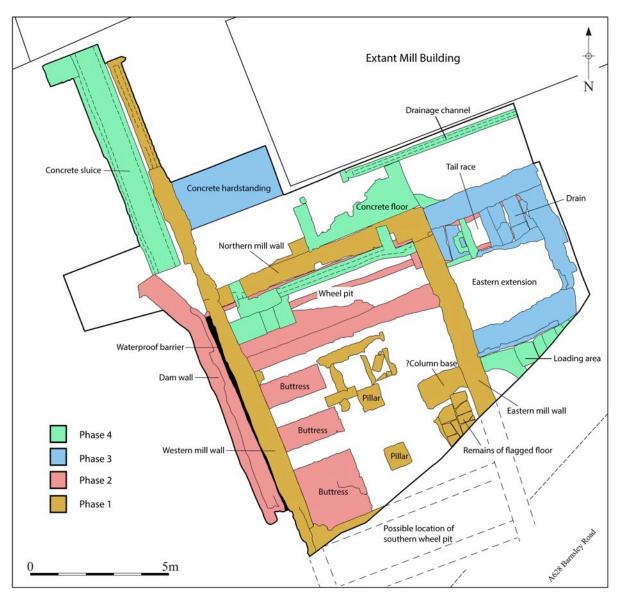
Figure 3 Phase plan

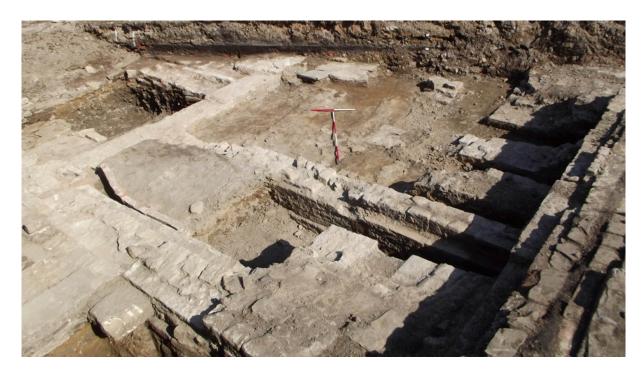
The earliest remains consisted of the rectilinear foundations of the main mill building (Fig. 4) which extended north to south across the excavation area. A paucity of finds makes it difficult to establish the date of this initial building phase, although it is probably of late-17th/early-18<sup>th</sup> century date. The structure is possibly based on the previous footprint of Skoute Mill, the first recorded mill on the site, although no evidence for this was revealed. The outer walls, constructed of dressed yellow sandstone, were all of the same width, measuring 0.65m, whilst the inner walls measured 0.45m in width.

Figure 4 Overall view of the main mill building, looking southeast. Scale: 2m/1m. © Wardell Armstrong.

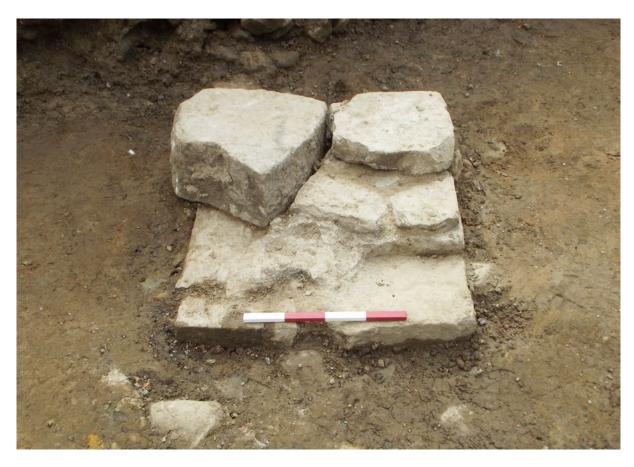
Within the interior of the building a flagged floor was present which was built onto a layer of natural clay, with the remains of two small square stone structures also visible. These two small structures survived below the flagged floor and appeared to be built from the remnants of a previous mill with a large piece of millstone forming one of the corners (Fig. 5). The function of these small structures remains unclear although they may have formed the basis of a pier system on which the flagged floor was laid, or they may represent the possible bases for the power transmission associated with the waterwheel.

Figure 5 Piece of millstone in situ, forming part of a possible machinery support. Scale: 0.5m. © Wardell Armstrong.

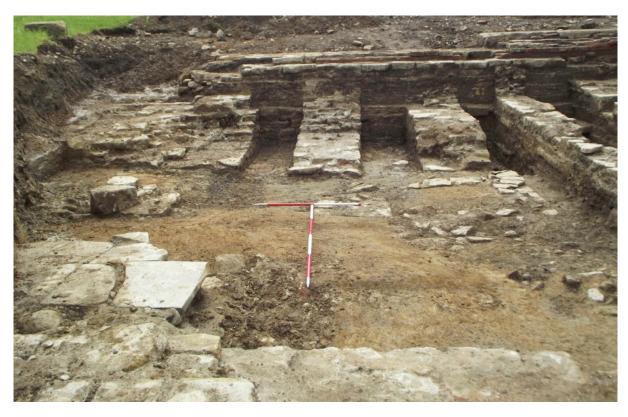
The excavations revealed that the second phase of the building was largely associated with its refurbishment and expansion under Mary Grammar in 1713. The main structural remains of this phase comprised the dam wall and its supports situated to the west. The dam wall survived in good condition to a width of 0.90m and was constructed from substantial, bonded yellow sandstone blocks. It was observed to have a length of 8.40m and a surviving height of 1.30m. The dam wall was not built directly against the existing mill building (Phase 1), with the gap between the two filled with a hard, black industrial waste possibly forming a waterproof barrier. This layer measured 0.12m in width and was visible along the length of the dam wall, along with two courses of mortared red bricks, the use of which remains unclear. It is likely that this construction was intended to prevent leakage into the mill. The dam impounded a millpond to the west of the mill, as depicted on 19th-century maps.

Figure 7 Buttress supports against the western wall of the mill building, looking southwest. Scale: 2m/1m. © Wardell Armstrong.

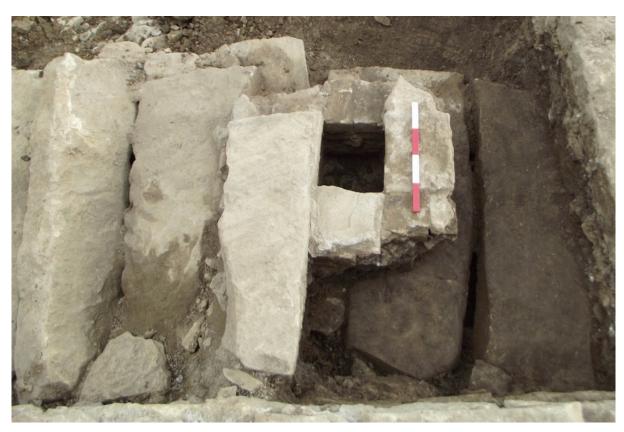
Running parallel to the extant building was a brick and mortared drain aligned east to west. This was constructed into the backfill layers covering the sandstone slabs, which in turn covered the tail race (Phases 2 and 3). The drain utilised the fall of the tail race. A concrete yard area in front of the extant building was also observed, with another drain associated with the extant building. This concrete yard may have been associated with the later redevelopment of the mill, but could also post-date the mills demolition.

Figure 9 Drain cut through sandstone blocks. Scale: 0.5m. © Wardell Armstrong.

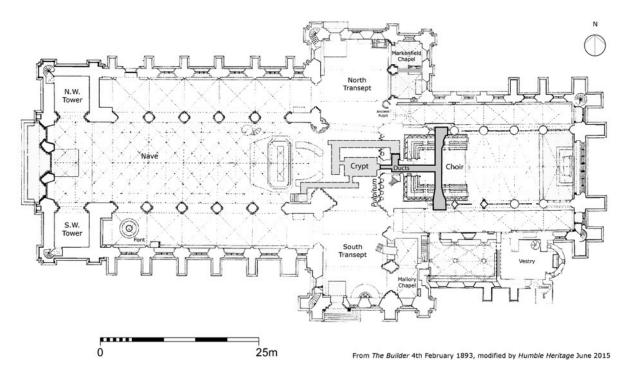
In 2013 the underground trunking that feeds air to the organ at Ripon Cathedral was removed for replacement. This maintenance event allowed unencumbered physical access – probably for the first time since 1878 – to a series of Victorian brick-built ducts that run beneath the present day Quire and close to Ripon's internationally significant 7th century crypt. The crypt is the oldest remaining built fabric of any English cathedral (excepting the re-use of Roman materials in some cathedrals), which has been in continuous ecclesiastical use since its construction and has survived without substantial alteration (Fig. 1).

**Figure 1** Plan of the cathedral showing location of the Victorian organ ducts and the 7th century crypt. (Base plan after The Builder 4th February 1893, with modifications by Humble Heritage 2015)

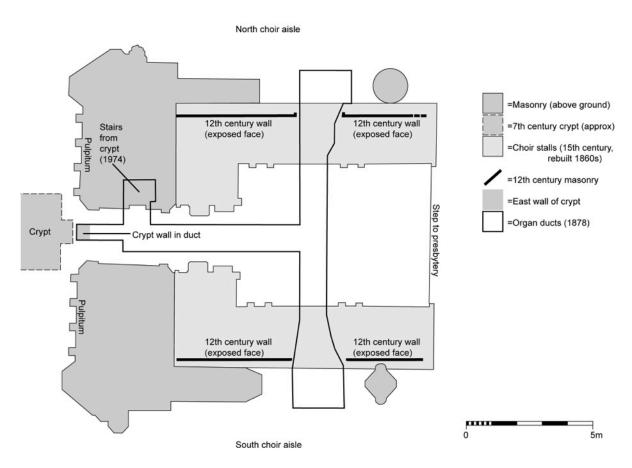
Two parallel lines of mortared stone wall were visible in the voids adjacent to the north and south ends of the ducts (Figs. 3 and 4). The walls were visible to east and west of the duct and appear to have been cut through to insert the duct in 1878. Only the southward elevation of the north wall and the northward elevation of the south wall were accessible so the thickness of the walls remains unknown. The floor of the stalls above is supported by beams and joists, in part supported on loose stone blocks that rest on top of the mortared walls. Two courses of stone were visible in places on the northern stretch of wall (Fig. 5), but only one course elsewhere (mainly because of material obscuring the lower courses). The stonework was dressed and tooled and was bonded with lime mortar.

**Figure 3** Plan showing layout of the ducts and features of archaeological interest (after original by York Archaeological Trust).

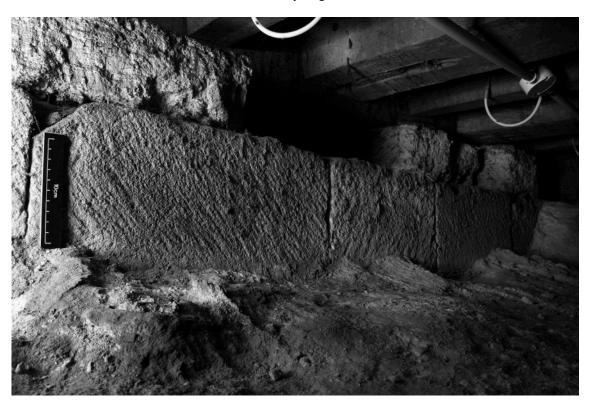
Johnson (2013, 6) suggested that, 'the striated tooling on the ashlar of the early walls is suggestive of a date around the 12th century' (Fig. 6) and that this showed that the walls were part of the well-documented rebuilding campaign initiated by Archbishop Roger de Pont l'Évêque (archbishop of York 1154-1181) (Walbran 1851; Wilson 1986; Harrison and Barker 1999). Archbishop Roger began rebuilding the entire church with a six bay Quire, three bay north and south transepts and a long aisle-less nave, retaining only the crypt. Too much weight should not, perhaps, be accorded to the form of the tooling as stone can be re-used in later contexts. It has been demonstrated that stone from Archbishop Roger's church has been re-used later in the medieval period elsewhere in the cathedral (Harrison 2013; Humble 2016 and forthcoming). However, in this case it seems to fit the stratigraphic position of the walls. There is not known to have been any building campaign in this location between the 1450 rebuild and the work of Archbishop Roger.

Figure 6 Photograph showing tooling on east part of northern wall. © York Archaeological Trust.

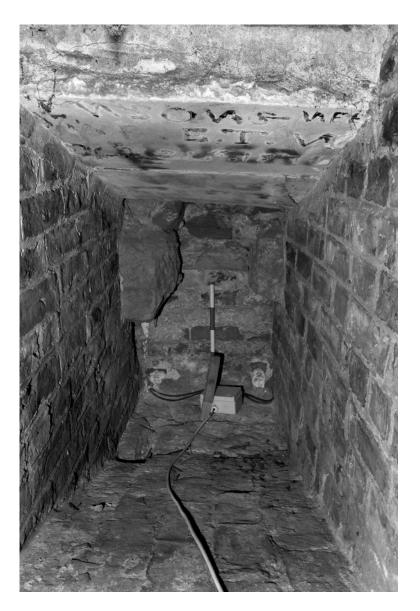
Figure 7 Photograph showing the wall of the 7th century crypt in the west end of the east-west duct. Sandstone blocks visible on the floor and above are the original walling with brick, rubble and mortar infill between. Slab with dated graffiti visible above. © York Archaeological Trust.

The explanation for the missing crypt stonework and its replacement with brick, stone and mortar, and the ragged, irregular shape of the opening that was made is provided by a passing remark by Micklethwaite, 'That [niche] at Ripon was opened out a short time ago, when those engaged in the erection of a new organ began to alter the old vault to fit it for the reception of some of their machinery. This was very properly stopped...' (Micklethwaite 1882, 353). This also confirms the date of the ducts as being contemporary with the 'new' organ (1878), replacing a mysterious and intriguing 'old vault' according to Micklethwaite's account, although no trace of previous work was apparent in the present investigation. Micklethwaite makes no further mention of this 'old vault' despite the fact that an ancient date might help support his theory of an original opening, so he must have believed it to be of relatively recent origin, possibly relating to the earlier organ. Some questions remain, particularly why the workers were intent on cutting through a thick sandstone wall to the crypt, how their duct came to be so precisely aligned with the eastern niche of the crypt, and whether they fully pierced the wall before being stopped. However, the present investigation produced no evidence to address these further questions or to clarify Micklethwaite's reference to an 'old vault' that pre-dated the 1878 ducts.

Having evidently successfully revisited later in 1989 to take the required measurements, Hall wrote of his findings in 1993. He concluded that the 1878 passage was slightly offset from the eastern niche of the crypt but was very close, with the thickness of remaining wall being just 200mm (Hall 1993, 49 and Figures 3-4). Unencumbered by the zinc trunking, the 2013 investigation was able to record the rear of the east wall of the crypt in more detail (Fig. 7) and for the most part confirmed Hall's observations. In addition to the stone exposed on the floor of the duct, of which one and a half blocks thickness was visible, two large blocks projected to either side in the upper part of the duct. Both the upper and lower stonework was made up of yellow, coarse-grained sandstone bonded with pinkish-coloured lime mortar. Above the upper stonework were a number of fragments of red sandstone, also bonded with pinkish mortar. The area between the upper and lower sandstone block-work was filled with a mixture of brick and stone fragments bonded with copious amounts of mortar. The upper and lower stonework is clearly the original fabric of St Wilfrid's crypt and the mixed stone and brick between them is post medieval or 19th century infill of a hole, although it was not possible to tell whether this had once pierced all the way through to the crypt chamber. Hall was of the opinion that it had not (Hall 1993, 48) and the present investigation offered no further evidence on the question. Only in one small respect did the present investigation deviate from Hall's findings; two electrical cables had been drilled through between the duct and the niche sometime after Dr Hall's 1989 visit, and from the relative positions of these on either side of the wall it was clear that the west end of the duct is situated directly behind the east niche of the crypt chamber.

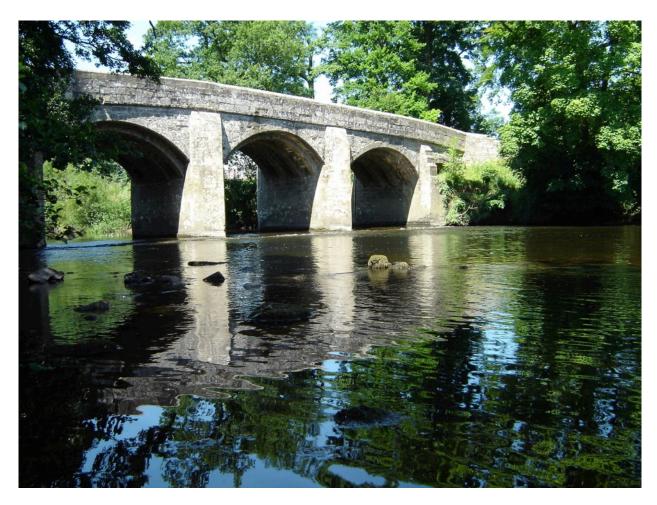
The stone-built bridge as it stands today comprises six segmental arches, of which four cross the river whilst the remaining two act as flood relief (Fig. 1). Each of the arches has four square ribs; there are string courses below the level of the parapets and the cutwaters are splayed back to the level of the tops of the arches. However, this is not the bridge as it was originally built and an examination of the bridge, particularly its underside, clearly shows how it has evolved over time. For ease of discussion the arches have been numbered from 1 to 6 from north to south. Arches 2–5 span the river and as such they have running water passing under them all year round whilst Arches 1 and 6 are well above the normal river level and act as flood relief during the winter months.

Figure 1 General view of the east side of Kilgram Bridge. © J. Buglass.

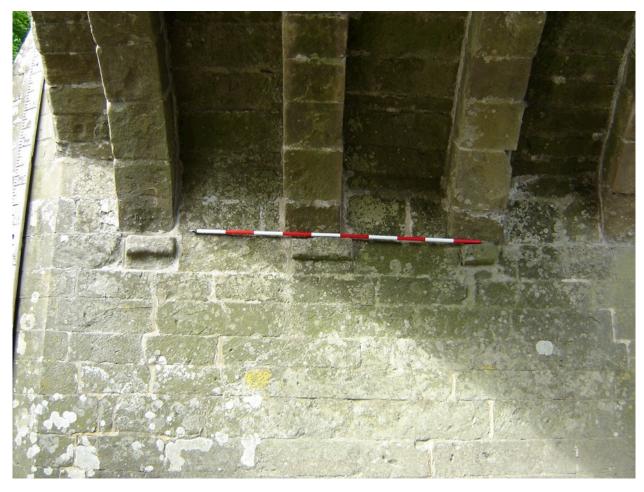
From an examination of the bridge it would appear that the original bridge was approximately a third narrower and probably had a flat, wooden deck; there are a number of reasons for suggesting this. The first of these is that set into the side of some of the bridge piers, directly under the springing point for the arches, there is a line of three stone corbels (Fig. 2). As the springing point for the arches does not require any support it would seem quite likely that these corbels are left over from an earlier (?original) form of the bridge. As corbels are typically used to support the end of a horizontal timber beam and as the corbels are present on several sides of the piers this strongly suggests that the bridge was originally built with stone piers joined by a wooden deck. This scenario would seem quite possible as it would allow for a bridge to be built relatively quickly and at a lesser cost than if it was constructed from scratch with the stone arches. These could be added at a later date when there was either the skills available or the funds permitted.

Figure 2 Corbels below springing point on the north side of Arch 2. Scale: 2m. © J. Buglass.

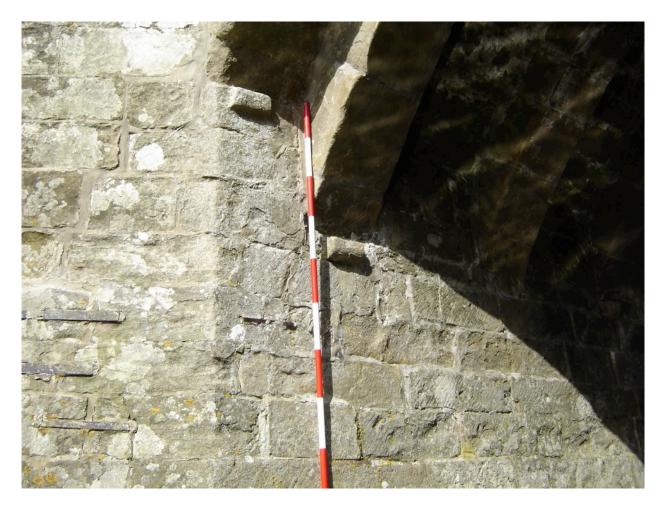
The second reason is that the corbels that are still present are all restricted to the western (upstream) side of the piers which strongly suggests that the original bridge was probably two-thirds the width that it is today. Interestingly there are the remains of corbels located at two different heights (Fig. 3). As discussed above the lower, larger, corbels would have supported the roadway whilst the smaller, slightly higher ones may well have supported some form of rail running along the edge of the bridge.

Figure 3 Different height corbels on Arch 3. Scale: 2m. © J. Buglass.

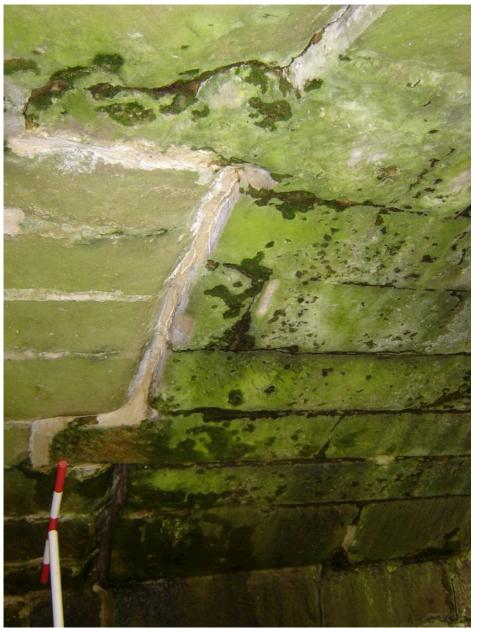
Figure 4 Butt joint in the different phases of the bridge seen under Arch 6. Scale: 0.5m. © J. Buglass.

When and why the earlier flat decked roadway was replaced is currently unknown – possible reasons include: the decay of the timber, flood damage or the availability of skills/funds. Though in terms of date it would seem that it was probably not that long after the original bridge was built as there is no significant difference in the finish and tool marks on the stone-work between the western (original) and eastern (later addition) sides.

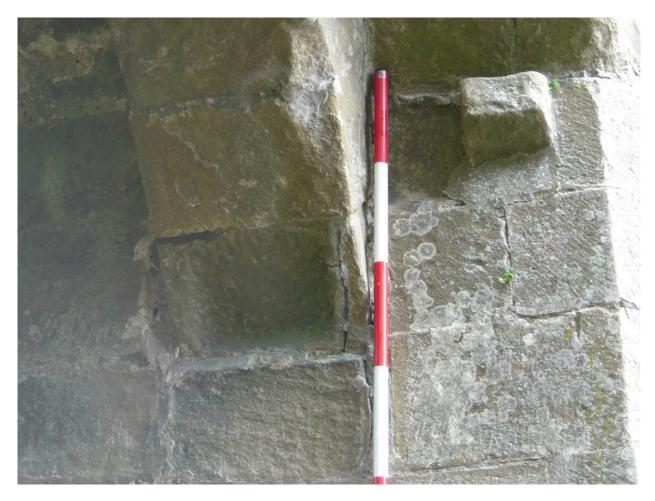
Figure 5 High level corbel and recess cut under the springing point in Arch 3. Scale: 0.1m units. © J. Buglass.

This combination of holes is only found in the southern side of Arch 3 southwards which would seem to show that the southern end of the bridge around Arch 3 required a significant degree of support at some stage after completion. It is proposed that the buttresses for Arches 4 and 5 were at some stage damaged, probably by a flood, and the southern part of the span for Arch 3 required support whilst the remainder of the bridge was re-built.

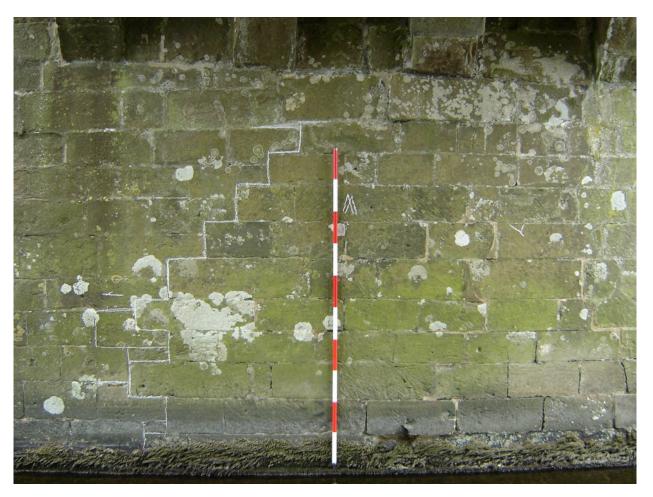
Further evidence for a major repair is a dramatic change in the coursing of the stones on the southern side of Arch 4 (Fig 6). This change appears to be coupled with the lack of symmetry and alignment of both the eastern and western sides of this buttress with the others. This lack of alignment would appear to argue that the eastern end, at least, of this buttress suffered considerable damage, and possible collapse, which lead to it being rebuilt. Finally, on the western side of the bridge above Arch 4 there is an additional levelling course just below the string course for the current roadway which further indicates some form of re-building.

Figure 6 South side of Arch 4 showing the marked change in the stone courses. Scale: 2m. © J. Buglass.

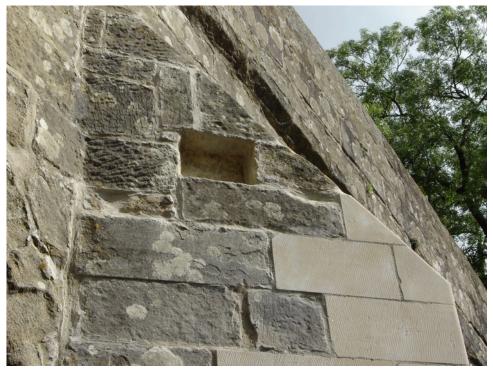
Figure 7 The missing stone in order to prevent the Devil taking his due. © J. Buglass.

The enduring story associated with Kilgram Bridge is its alternative name of the Devils Bridge (Cale 1998 and Darlington and Stockton Times 1997) which derives from an old superstition that 'Every bridge demands a life'. This is often taken to mean that as the number of potential souls for the Devil/water deities would be lost when there was no longer the risk of being swept away when a ford was replaced with the safer bridge and therefore the construction of the bridge would take a life to compensate for this (de Mare 1987, 8 *et seq.* cites several examples). The variation on this legend in the case of Kilgram Bridge is that a deal was made with the Devil that in return for the safety of the workers building the bridge the Devil would take the soul of the first person to cross the bridge once it was completed. Which is why, to this day, whenever repairs are carried out to the bridge there is always one stone left out so that the bridge is never finished (Fig. 7). This legend, and variations on it, have given rise to 'Devil's Bridges' which can be found in most countries and other well known ones in Britain are at Kirkby Lonsdale (Jervoise 1932, 131) and Ceredigion in Wales.

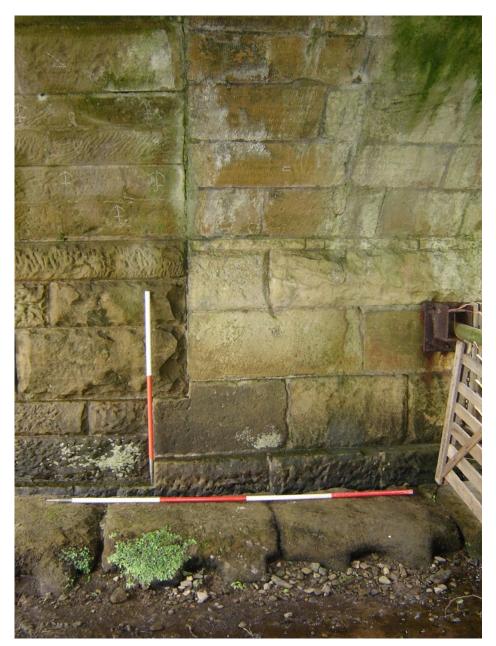
Figure 9 The old (right hand side) and new (1715) parts of Low burn Bridge. Scale: 1 and 2m. © J. Buglass.

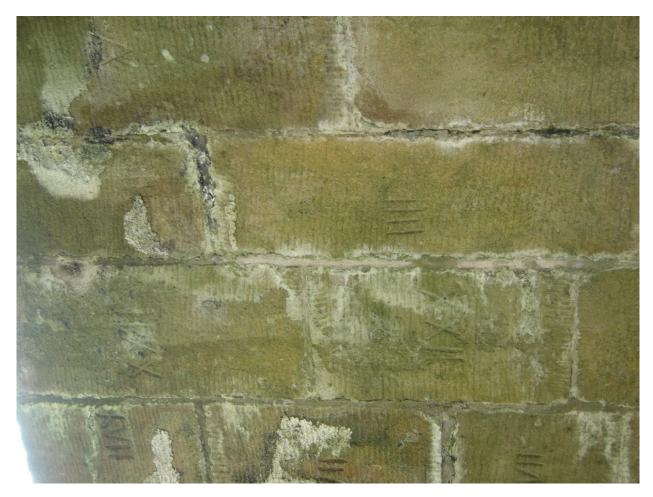
Figure 10 Roman numerals on the underside of the old portion of Low Burn Bridge. © J. Buglass.

In addition to the masons' marks this first phase of the bridge also contained a large number of blocks with Roman numerals cut into them (Fig. 10). The commonest explanation for these was that they represented the laying out and marking up of the blocks prior to their actual use in the construction. This may well have been at a place away from the site of the bridge, possibly even on the dressing floor at the quarry prior to the blocks being transported to their final location. By having the blocks pre-marked, as long as the building workers matched the same patterns of numerals they would be able to carry out the construction work, even if they were illiterate. The Historic England listing description for the bridge records that there are 20 types of masons' marks. It would seem from this investigation that this number includes Roman numerals as only 10 different masons' marks were identified in this study. Within the Roman numerals it is interesting to note that 24 is inscribed as both XXIIII and XXIV which would seem to indicate that at least two different people where involved in the setting out process.

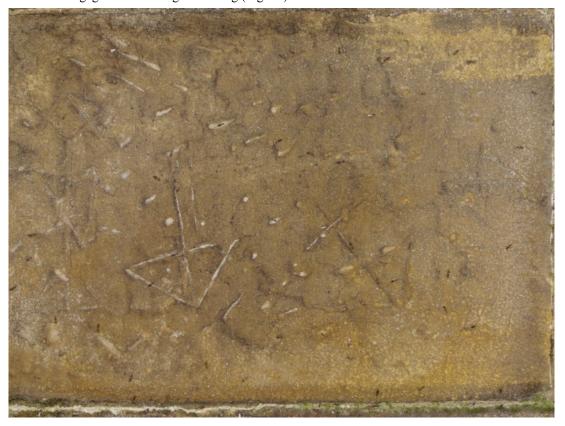
Figure 11 The 'signature stone' of the masons working on the 1715 bridge widening. © J. Buglass.

Unlike the earlier bridge the latter phase only contained masons' marks and no setting out/construction marks; however it did contain one unusual block. In the apex of the northern most arch of the second phase bridge and directly adjacent to the old bridge there was a single stone block which contained at least four of the masons' marks seen elsewhere in the second phase bridge. It is possible that this represents the 'signature' of some or all of the workforce engaged on the bridge widening (Fig. 11).

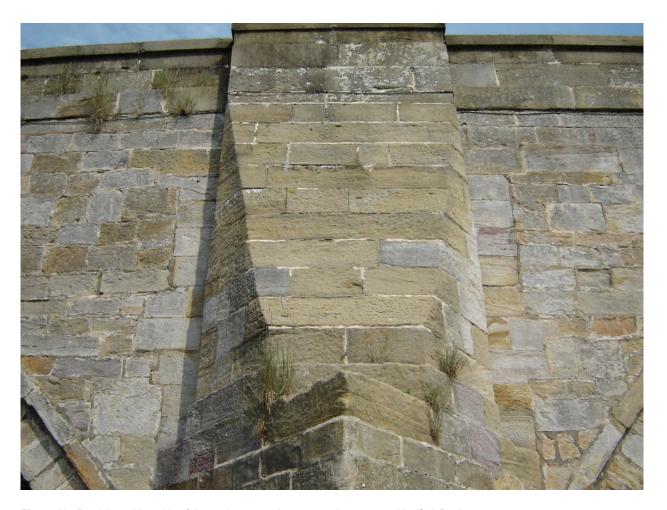
Figure 13 Butt joints either side of the northern most buttress on the western side. © J. Buglass.

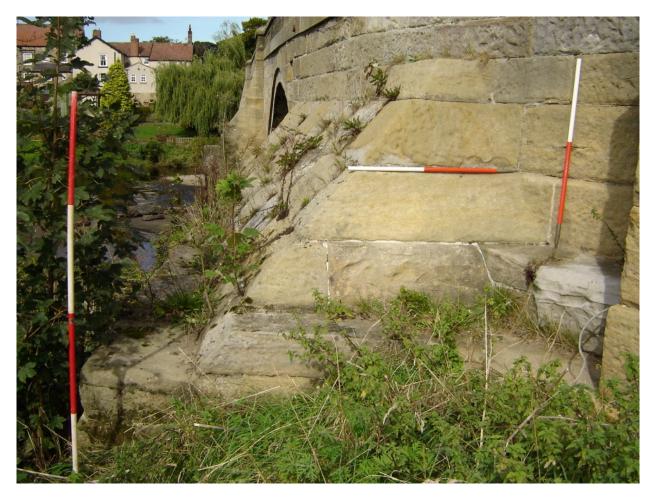
Figure 14 Unusual stone structure on the south-west side of West Tanfield Bridge. Scale: 1 and 2m. © J. Buglass.

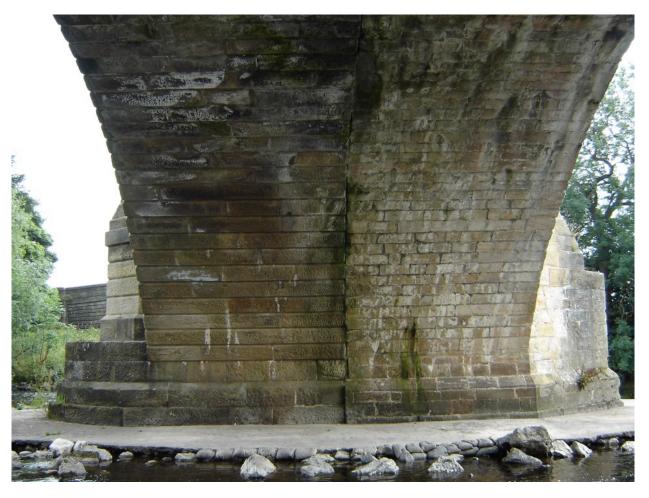
Figure 16 The underside of West Tanfield Bridge showing the older (right hand side) and newer (?1842) parts of the bridge. © J. Buglass.

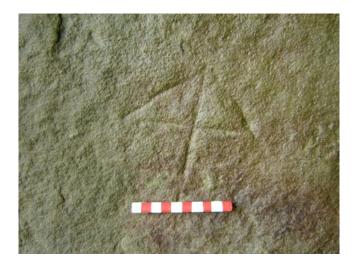
Figure 17 Masons' marks on Low Burn Bridge. Scale 10cms (where shown). © J. Buglass.

Masons' or Bankers Marks – these marks are the ones most commonly seen and appear to relate to the skilled workmen who were responsible for squaring the stones or making the more complex mouldings for windows, doorways, etc. (Fig. 17).

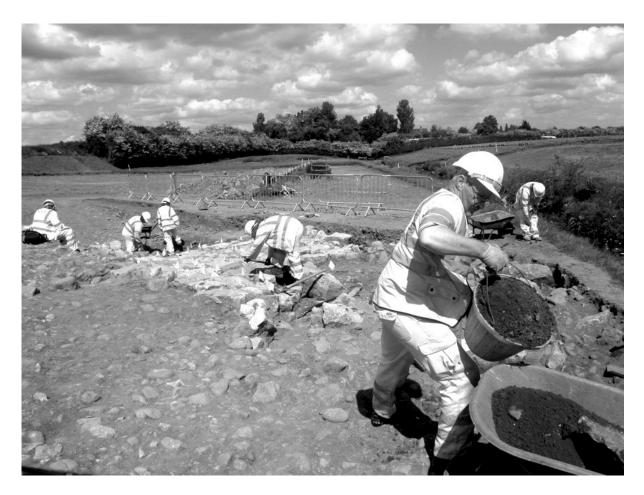
Figure 2 The structure during initial cleaning, looking north-east towards Catterick village. The Brough Beck lies to the right.

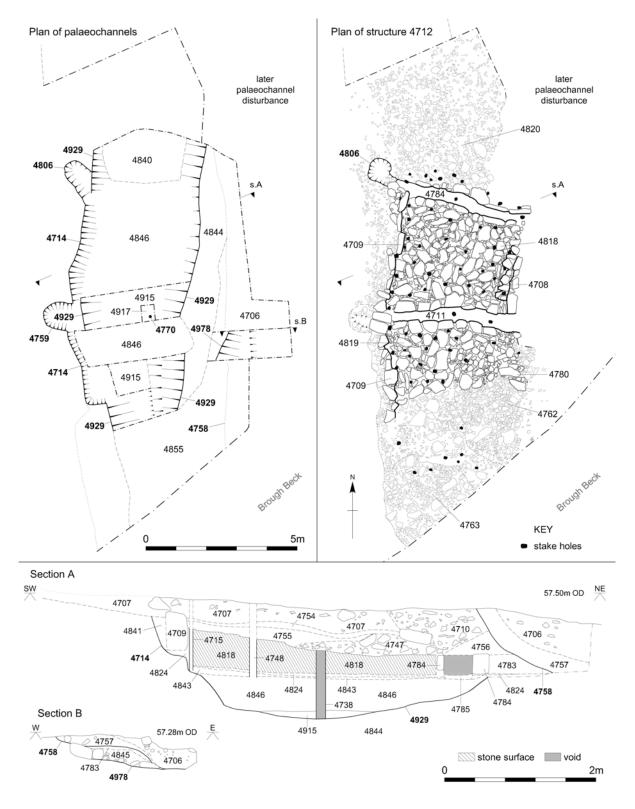
Figure 3 Plans of the palaeochannels of the Brough Beck crossing the excavation area (L) and structure 4712 (R), and sections. © NAA.

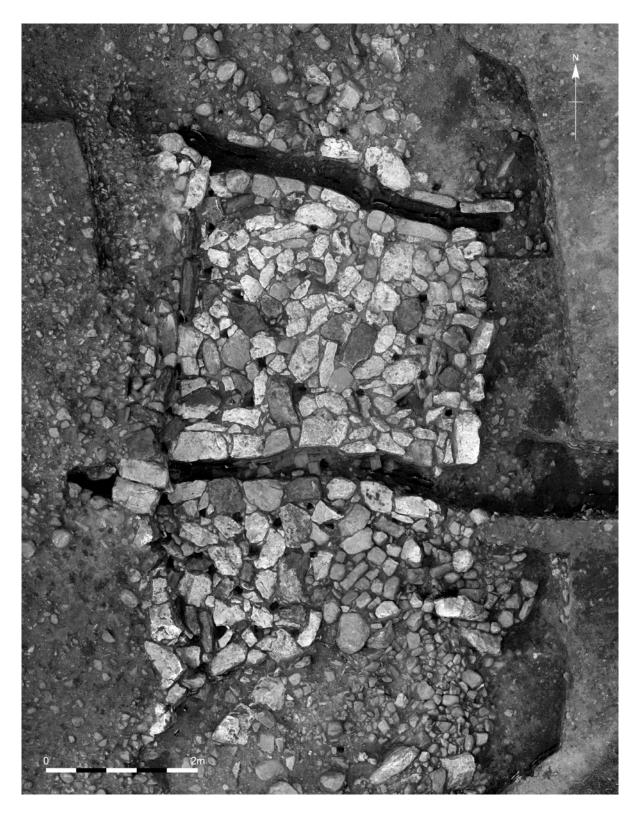
Figure 4 Composite rectified vertical photograph of structure 4712, facing north. The Brough Beck lies immediately to the lower right, running from lower left to upper right. Scale: 2m. © NAA.

A substantial timber structure was then erected upon this platform (Figs. 3 and 4). A timber ground-beam was set against the side of terracing cut 4714, its position marked by a linear gap between the cut and a parallel line of large upright packing stones 4709 placed against its eastern (internal) side. This large timber appears to have been c.0.3-0.4m wide, its position represented by sand (4841) which had filtered into the space as the wood decayed. More substantial evidence for similar ground-beams forming the northern end and central subdivision of the structure was provided by stone-groups 4784 and 4711 (Fig. 3), formed of large upright stones arranged on either side of linear slots. The silt infill (4785) of slot 4784 produced a residual struck flint. Additional packing stones suggested that the central ground beam extended slightly beyond the western wall line of the structure.

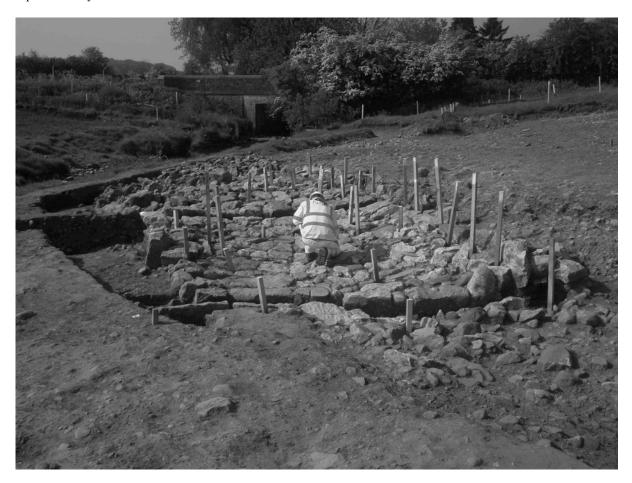
Figure 5 Structure 4712 looking south-west, with most of the voided stakeholes marked by wooden pegs. The modern course of the Brough Beck lies beyond the structure. © NAA.

Some of the post-pipes, together with the central part of the backfill of post-pit 4759, were detected well above the level of the stone floor of the building (indeed before the presence of a building had even been recognised). Given the distribution of the stakes across the interior of the building, which would have rendered the rooms unusable (see Fig. 5), it seems unlikely that they were associated with the initial phase of the building represented by floor surfaces 4818 and 4819.

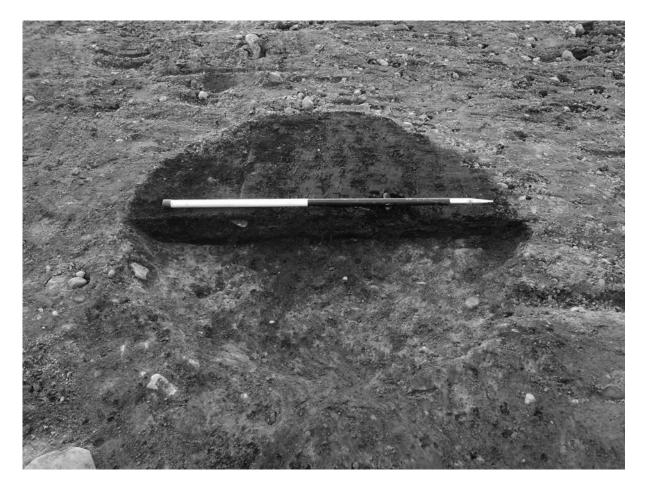
Figure 3 Pit 4009 showing in situ burning. Scale: 1m units. © Wessex Archaeology.

Ten circular shallow pits with flattish bases, and one that was oval in shape, were recorded among the ditches. They were 0.9–1.7m in diameter and up to 0.22m deep. Each contained in situ burnt material, generally with a black basal layer and sometimes with a grey upper layer (Fig. 3), although this was inverted in one instance. Each layer was heavily laminated, indicating repeated episodes of burning. Heat-affected natural was present below some of the pits. One pit (3009, Fig. 1) contained two sherds of Romano-British greyware, but the others contained no finds; the sherds may be intrusive or residual, and the dating of these pits is uncertain.

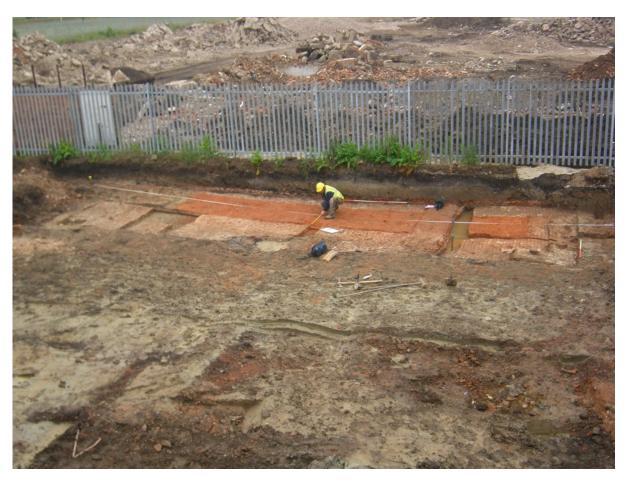
The Brickyard 2 kiln (Fig. 2) survived as three parallel brick surfaces built directly onto natural clay with the central surface shorter than the outer two. Ceramic field drains running along each side of each surface connected into a larger field drain to the north. The brick surfaces had slumped in several places, probably due to the clay below drying out and the weight of the overlying brick clamps. As a result the surfaces had been levelled up on a number of occasions with spreads of crushed brick and mortar (Fig. 3). Bricks pressed into the surface of this mortar may have been left over from the final firing. High temperatures associated with the firing of the kiln were presumably responsible for the heavily heat-affected clay deposit extending beneath the brick surfaces, with this most intense at the southern end of the kiln.

Figure 2 Zac Nellist working on Kiln 2.

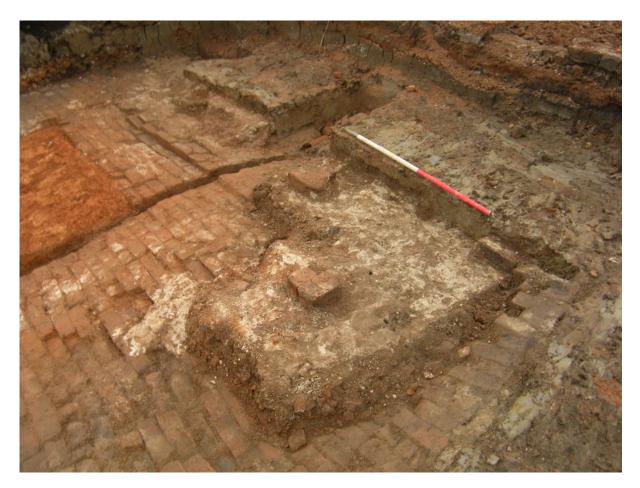
Figure 3 Details of repairs to Kiln 2. Scale: 1m units.

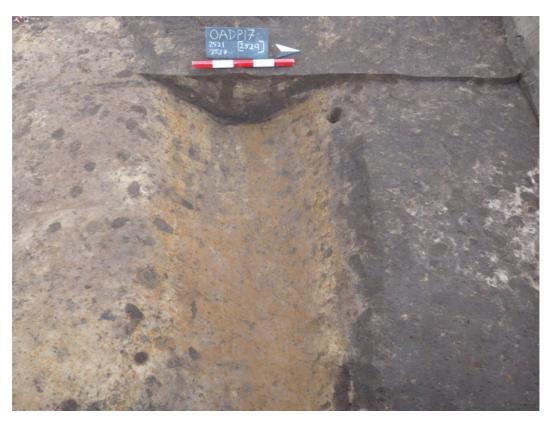
Figure 2 Excavation of one of the ring ditches in trench 5. © Archaeology North Duffield.

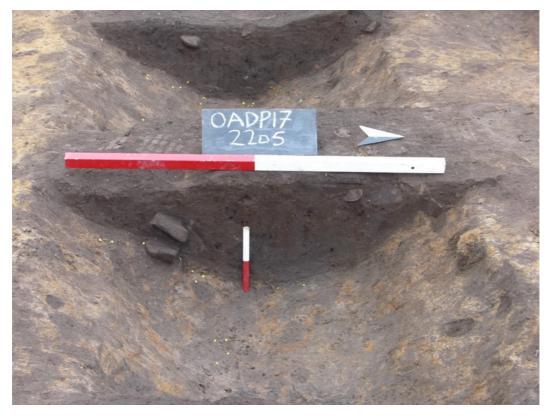
Figure 3 Two sections through ring ditch in Trench 2. © Archaeology North Duffield.

We have recently concluded the first dig, at West End Farm, Hemingbrough (Figs. 2 and 3) and recovered over 1000 sherds of Middle Iron Age pottery, thatch weights, evidence of iron working and perhaps glass making as well. This could well be the largest assemblage of Iron Age pottery yet found in the Vale of York. 80 people volunteered to dig, including adults with learning disability and a group being educated at home by their parents.

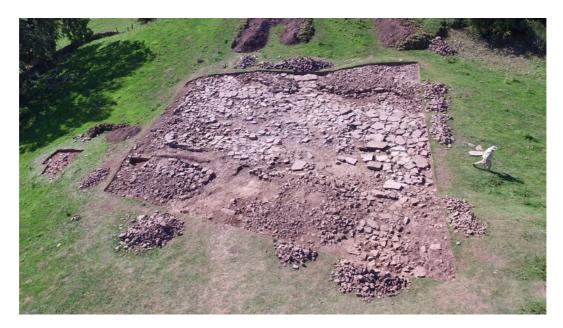
Figure 2 Overhead view of the site. © SWAAG.

During the two weeks of the dig we opened up an area some 400 square metres. Previous evaluation trenches had suggested that the excavation site might contain round houses. However, that was not to be the case; the site proved to be a paved and cobbled area, possibly a yard. It was bounded by the remains of walls and there were several entrances. One paved entrance featured a door sill, and from the topography and previous excavations of the adjoining area, it may well be the entrance to a round house (Fig. 5). Several of the paving slabs in different areas of the site were lifted but there were no visual indications of earlier occupation but we took soil samples for analysis.

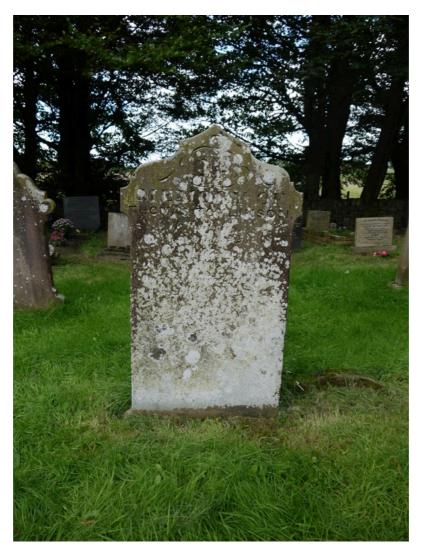
RTI has transformed the project and was introduced to members of the team in 2014 by Drs Gareth and Nicole Beale. It has been used for a number of years in Archaeology. It is a non-invasive computational photographic method that captures a subject's surface shape and colour and enables the interactive relighting of the subject from any direction. It consists of taking multiple photographs from a fixed position, moving the light source between each exposure and processing the resulting images in RTI Builder and then RTI Viewer. We have completed over 150 RTI's at St Mary's (Figs. 2 and 3).

Figure 2 Plain digital photograph of Tomlinson gravestone. © Alan Williams.

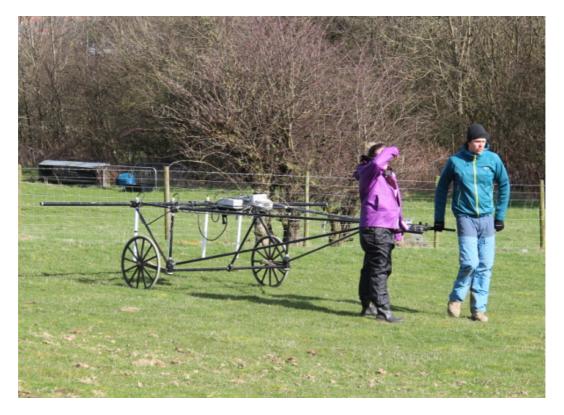
The main event has been the continuation of the Birstall field project. A chance meeting with Dr Chris Gaffney at Bradford University resulted in a day of magnetometry surveying on our field in March 2017 (Fig. 2). As well as his students, he persuaded Geoscan to come out and test a new device as well as getting Magnitude, a commercial survey company in Bradford, to carry out a full survey of the field with a 4-magnetomer array on a trolley. Our group also carried out some more resistivity work before the grass crop started to grow.

Figure 2 The magnetometry survey in the field. © Mike Turpin.

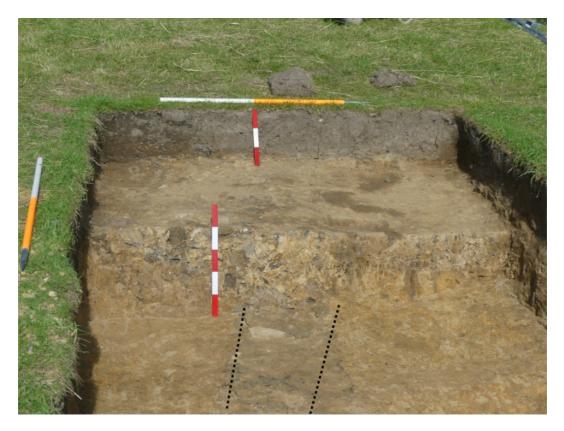
The first trench showed signs of some archaeology with changes in the nature of the clay. The natural clay had a feature running through it filled with clay mixed with signs of burnt material and coal within a linear cut (Fig. 3). It is suggested that this might be a robbed out wall foundation. No finds were excavated and so no dating evidence could be found.

Figure 3 A section through the clay suggested a filled feature which was provisionally identified as a robbed wall foundation. Scale: 0.1m units. © Mike Turpin.

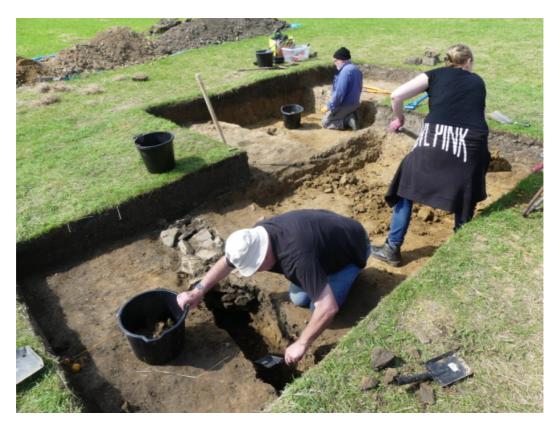
The geophysics showed a particularly high resistance response just to the side of where we had positioned the trench. After a discussion with our interested farmer, he agreed that we could extend the trench by another 4m x 2m (Fig. 4). The high resistance response turned out to be a linear cut which had been filled with randomly shaped pieces of sandstone. Our farmer suggested that we could be looking at an early field drain of a type called a French Drain. Again, we found no dating evidence in the trench, with no finds in either the clay or amongst the stones in the drain which had been removed and then replaced. An interim report is planned to be published over the winter.

Figure 5 The original trench is in the background with the extension showing the field drain. © Mike Turpin.

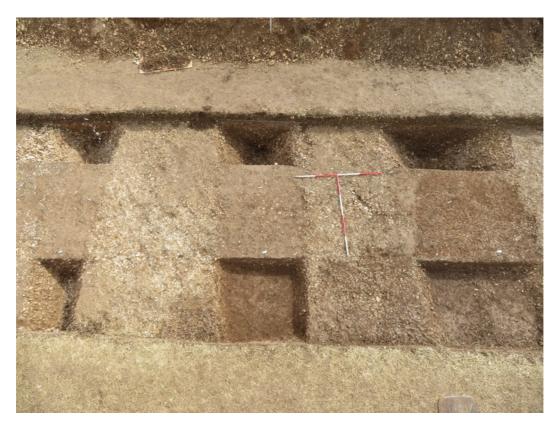
In trench AA (Fig. 2), the two ditches and a trackway became three ditches, all of which contained Roman pottery. Precise phasing of the ditches awaits the specialist report.

Figure 2 Trench AA.

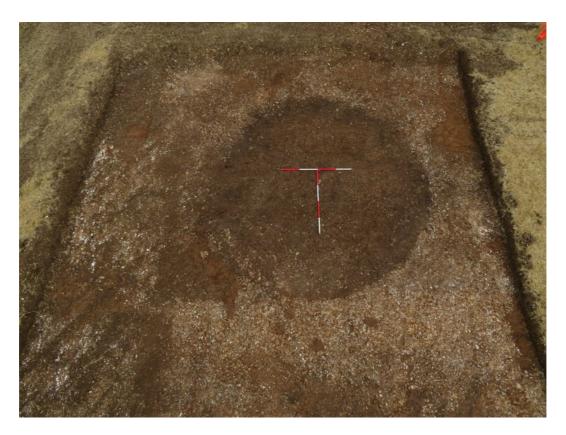
The two photographs (Figs. 3 and 4) below are of Trench AB. Removal of the topsoil revealed a circular feature of 6.35m diameter and excavation resulted in the section as illustrated. The feature is a large pit, almost perfectly circular and over 1m deep. It was backfilled in the late Roman period, but its original purpose remains enigmatic. We are open to suggestions as to its function if you have seen anything similar.

Figure 3 Trench AB revealing the circular feature.

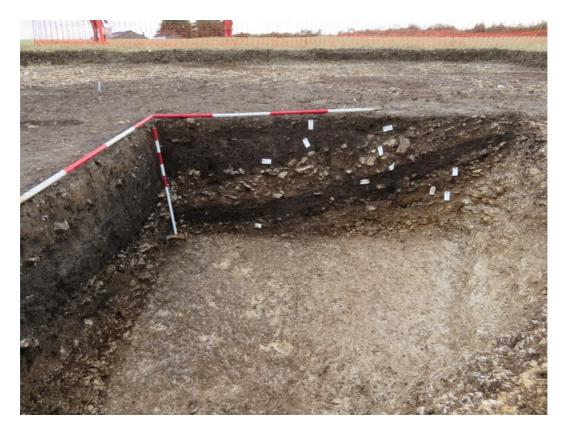
Figure 4 Trench AB showing the 1m deep large pit.

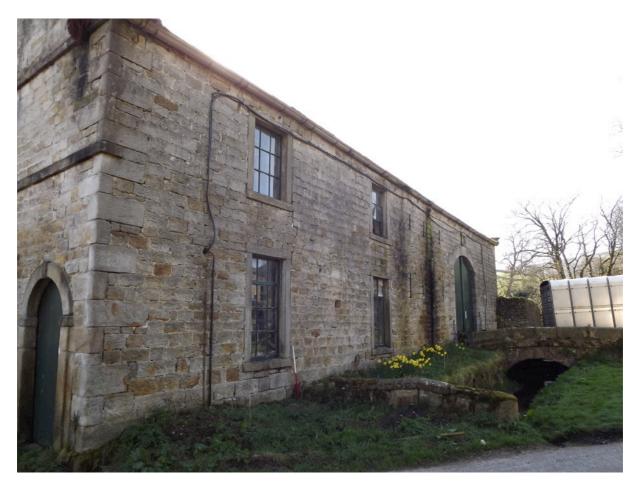
Figure 1 Manor Barn looking south-east, with meeting room on upper floor over stables. © J. Buglass.

The barn has a pair of large double doors in its western elevation with a smaller doorway in the opposite, eastern, wall. This combination of openings may well have provided sufficient through flow of air for some small-scale threshing as well as hay storage.

At some point, probably in the latter 19th century, a series of alterations were undertaken on the barn. The main ones of these included a sub-division of the main hay barn to create of a series of new rooms at the northern end; the construction of an external staircase to the over coach-house accommodation and the refurbishing of this accommodation with larger windows and a fireplace for use as a meeting room. Local testimony records that this meeting room was used during the 19th century for services on Sunday afternoons, alternating between the Church of England and the Wesleyan Methodists (Townend 2016).

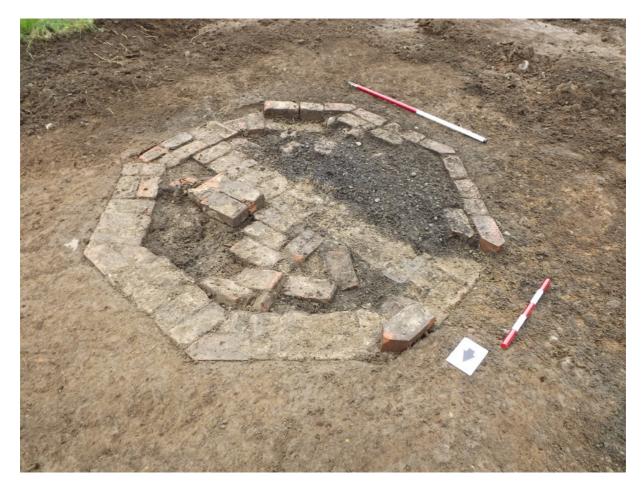
Figure 2 Red House Ripon, brick base of garden feature looking south-east. Scales 1 and 0.5m. © J. Buglass.

The watching brief recorded a range of 19th century archaeological remains. These remains consisted of part of the northern wall of the earlier *Hope House* along with various minor elements of its associated garden. These elements included the corner of the walled garden to the rear of the house; the line of a further three sections of garden walls; sections of cobble paths which would have wound round the garden and a flight of stone steps linking two terraces. In addition to these the outline of the foundations of the greenhouse to the east of *Hope House* along with what appeared to be an associated 'boiler room' were also recorded. Probably the most interesting garden feature was the remains of the base of a brick-built structure – probably the base for statue, sundial, armillary globe or similar (Fig. 2).

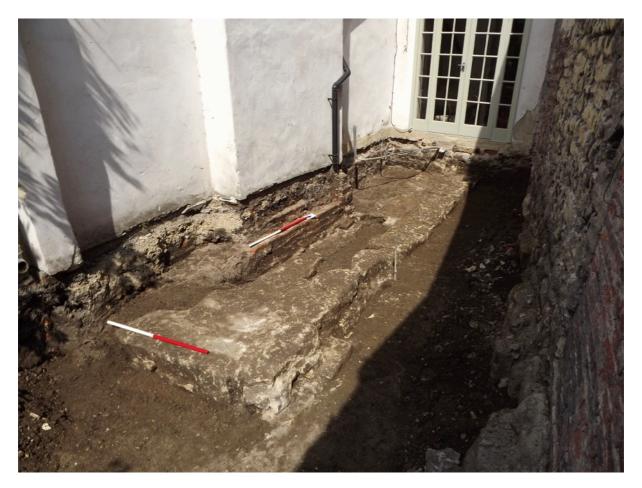
Figure 4 Remains of wall and fireplace at St Agnes Loge, looking north-west. Scale 1m. © J. Buglass

The archaeological investigation recorded a part of the remains of a substantial earlier building and appear to be a section of its eastern wall with a return at its southern end to the west along with a base of a fireplace (Fig. 4). The remains had been built from roughly dressed local stone and in places survived to at least two courses. The lowermost course that was visible had been bonded together using a very stiff clay matrix whilst the surviving second course had been bonded with lime mortar.

The remains of the fireplace were represented by a rectangular recess set in to the inner face of the eastern wall. Within this recess there were the remains of a stone base with a few bricks from its original hearth surviving under the base of the 17th century fireplace and chimney which had been built over it. From a study of St Agnes Lodge carried out by Jen Deadman the current building on the site is dated to the 17th century (house owner *pers. comm.*) and it appears to have been built from a certain amount of re-used material from an earlier building. The portion of the foundations uncovered during building works would appear to be the remains of that earlier building.

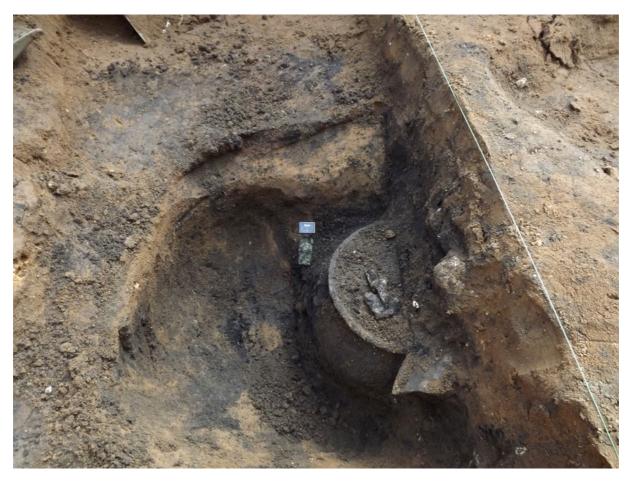
Figure 5 Part excavated bustum at Norton School, looking south-west. Scale 2cm on copper alloy brooch. © J. Buglass.

The watching brief which followed on from the open area excavation mentioned in last years *Forum* at the new school at Norton came to an end in late 2017 and continued to produce archaeological surprises. In addition to the extensive Roman remains previously covered the excavation of a service trench revealed an unusually complete Roman cremation burial known as a *bustum* (Fig. 5). The on site excavation of the pot produced a small enamelled brooch and two copper alloy belt plates – one of which has been provisionally dated as Severan (3rd century) to early 4th century AD and appears to have a close parallel with one found at Catterick in 1972. The pot itself is currently considered to be a Dales ware jar of 4th century date and having undergone x-ray at Leeds Royal Armouries it was micro-excavated in the YAT conservation laboratory. The micro-excavation recovered a further 14 copper alloy and 11 iron finds which are now under going identification and conservation.

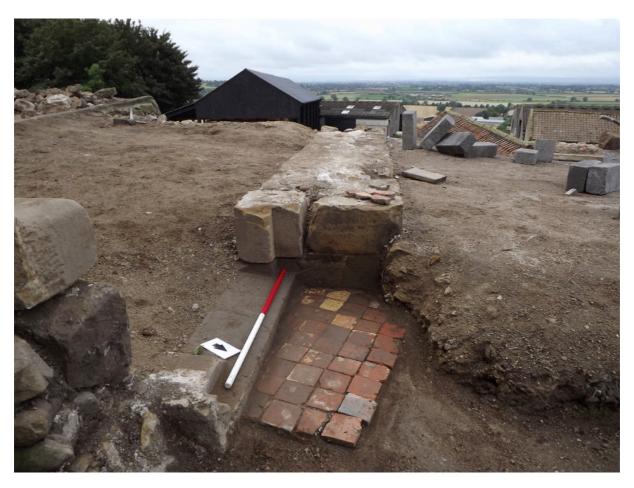
Figure 7 Harlsey Castle, in situ late medieval/early post medieval tiles on upper floor, looking west. Scale 1m. © J. Buglass.

A watching brief was carried out as part of an extensive programme of consolidation works on the remains of Harlsey Castle. In addition to monitoring the ground-works a photographic record was made of the repair and consolidation works as they progressed. This part of the process recorded ten areas of interest which contained architectural features of earlier phases of the castle. In addition eight fragments of architectural stone-work were recorded. The architectural stones were mainly elements of doorways but included at least one fragment of a stone chimney pot. Probably the most significant discovery was a small area of apparently *in situ* medieval floor tiles adjacent to a door sill on what is now the roof of the castle – the upper storeys having been demolished on the past (Fig. 7).

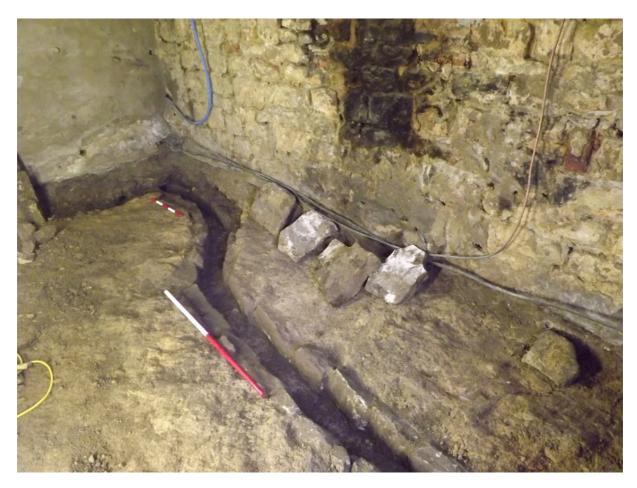
Figure 8 High Peak Cottage, serpentine stone lined channel, looking north. Scale 1m and 0.5m. © J. Buglass.
