SWINNOW PARK WETHERBY, WEST YORKSHIRE

Archaeological Excavation and Historic Development

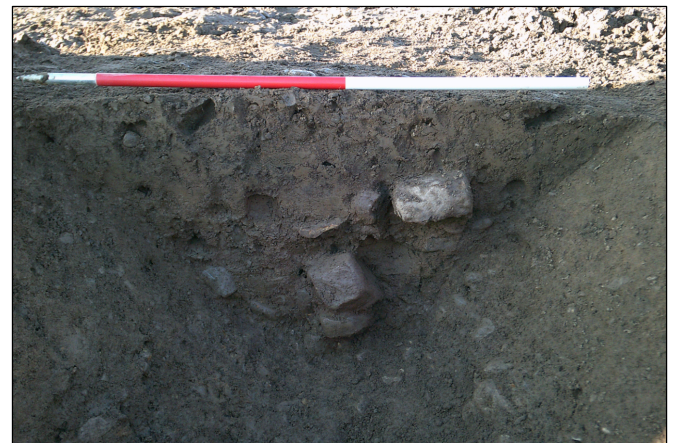
Plate 3: Ditch 12091 (Ditch 1), looking west

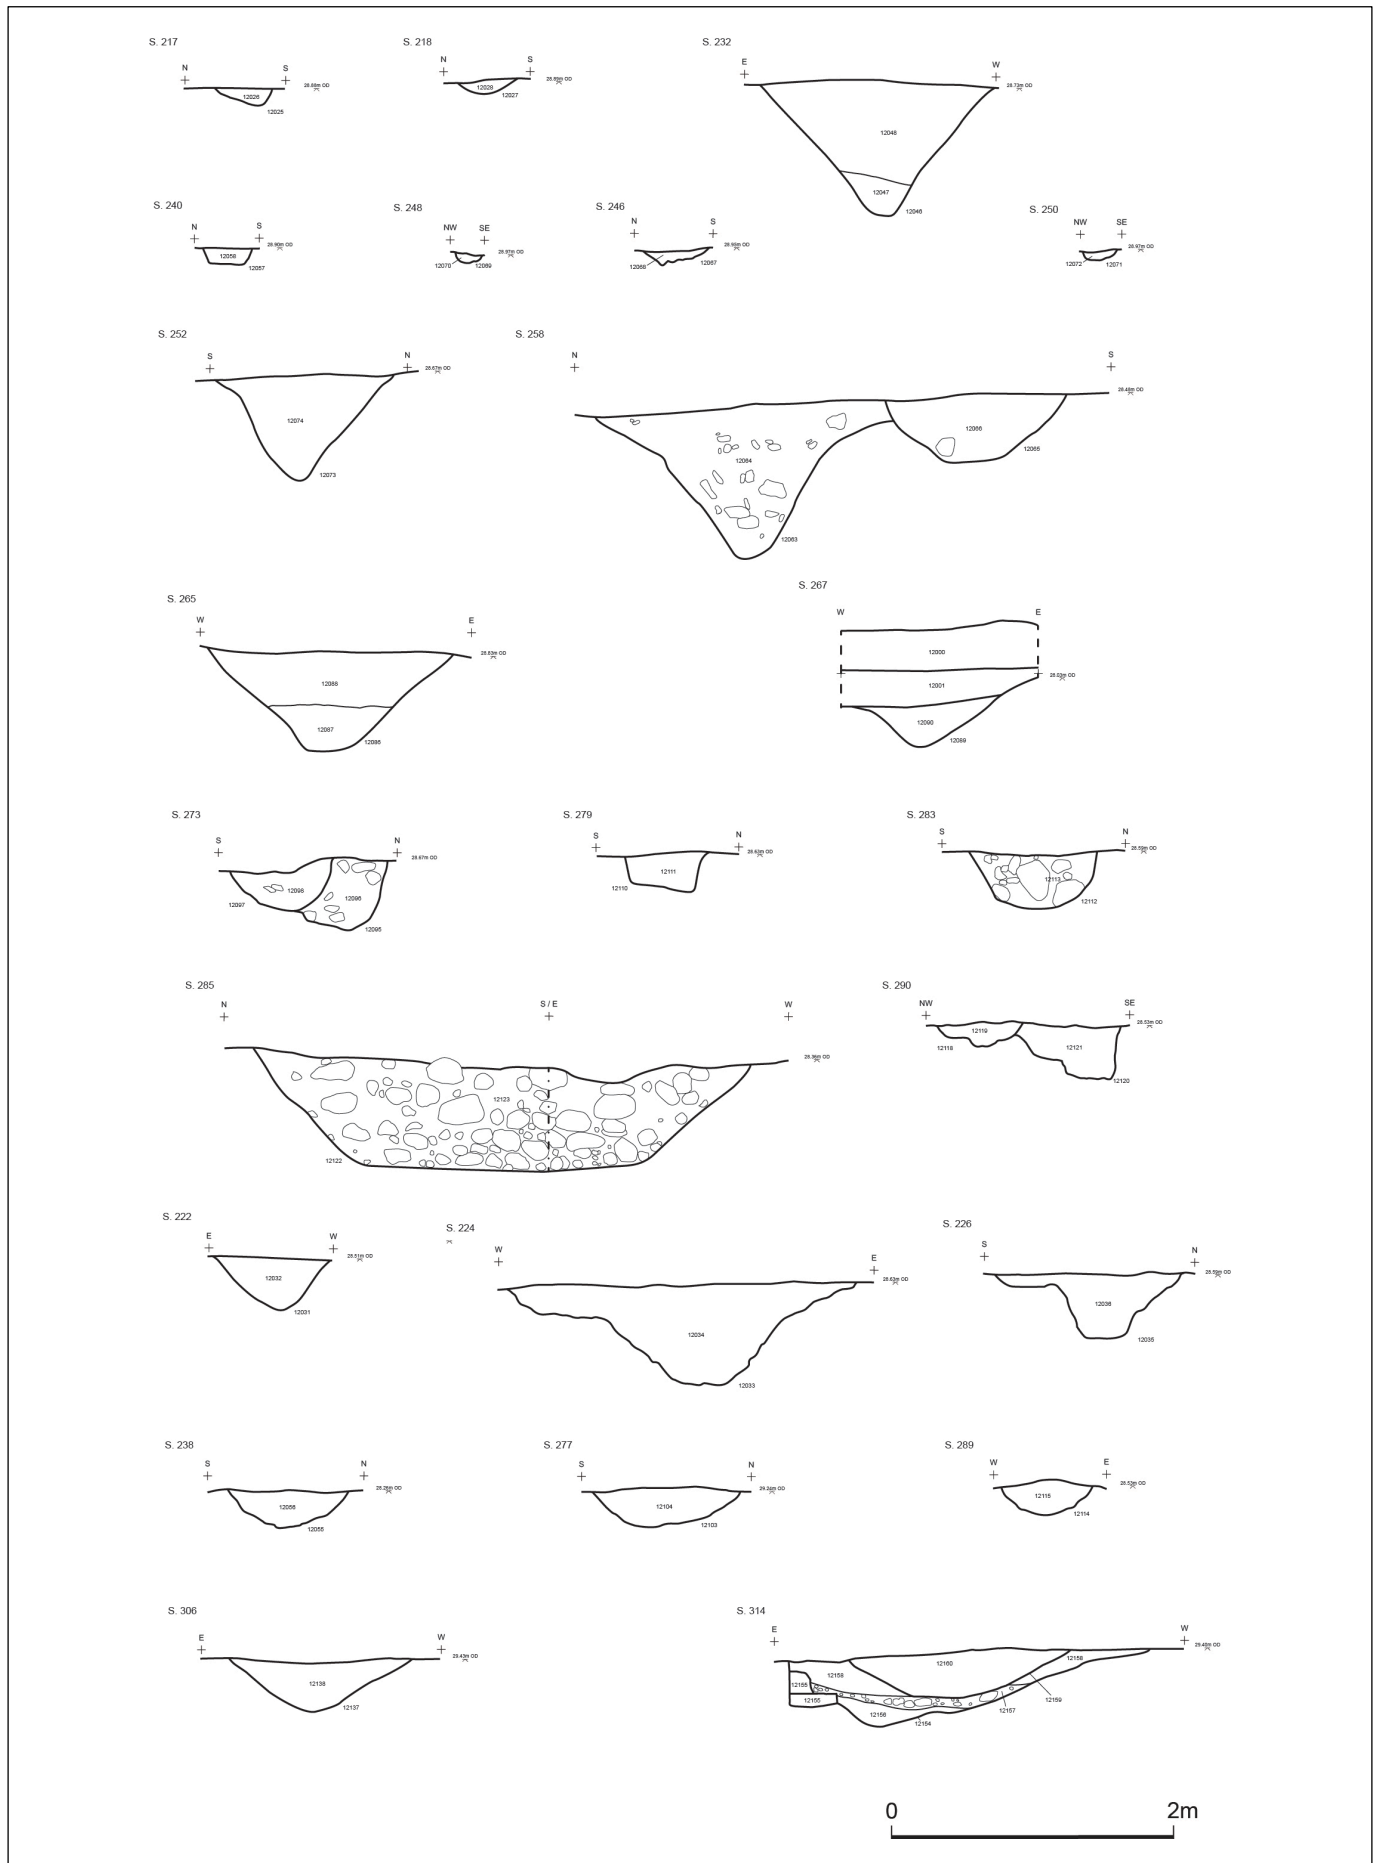
Figure 7: Area 2, sections

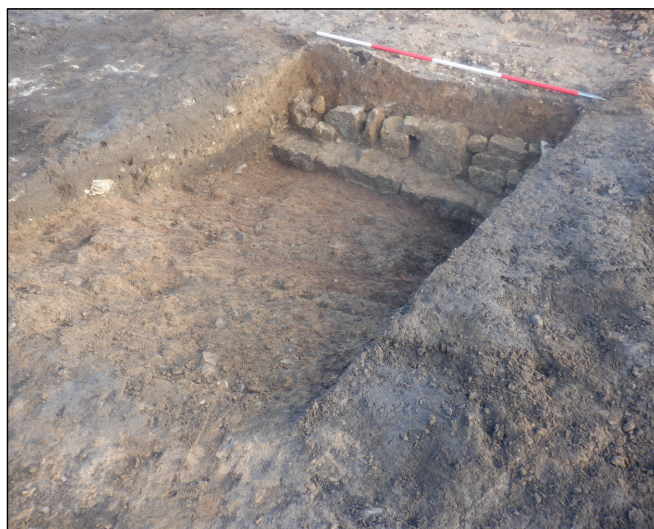
Plate 9: Ha-ha ditch 12161, looking north-east

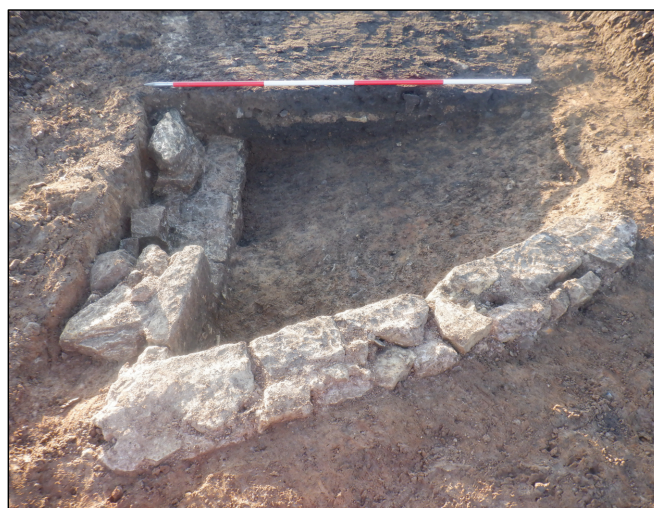
Plate 10. Ha-ha ditch terminus 12168, looking south-west

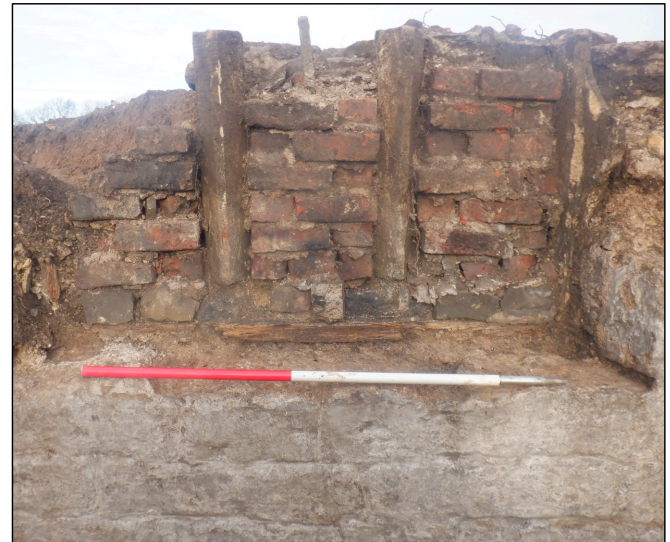
Plate 11: Window 13042, looking north

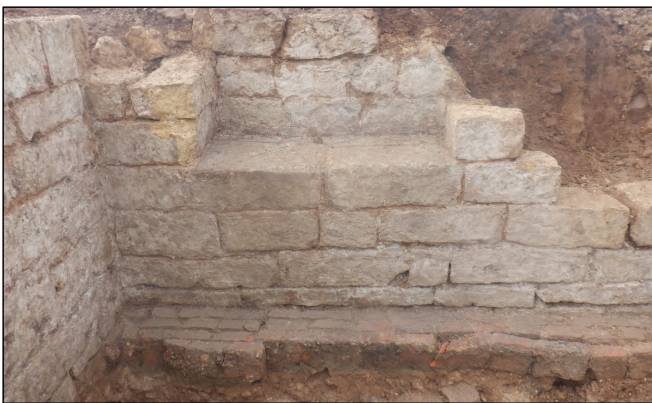
Plate 13: Elevation of the cellar wall showing a brick floor at the base, looking north-west

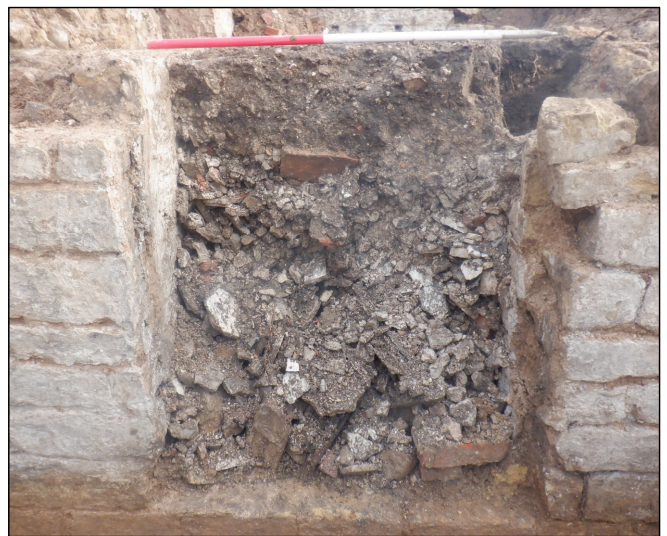
Plate 14: Doorway into Cellar 2, looking east

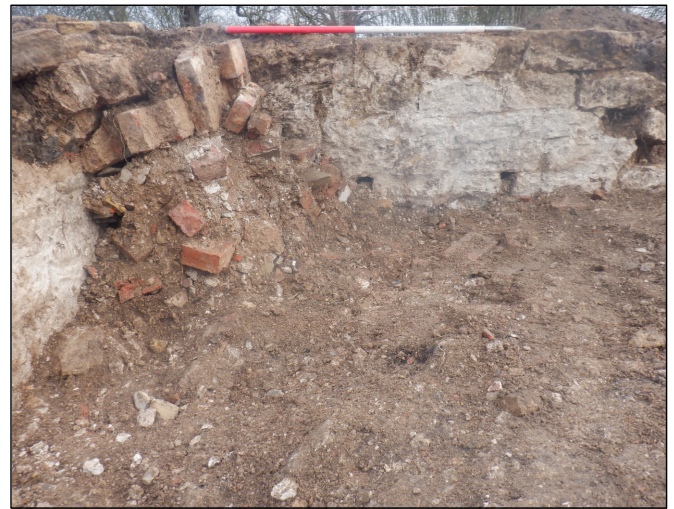
Plate 17: Wall 13029 and remnants of vaulting in Cellar 2, looking east

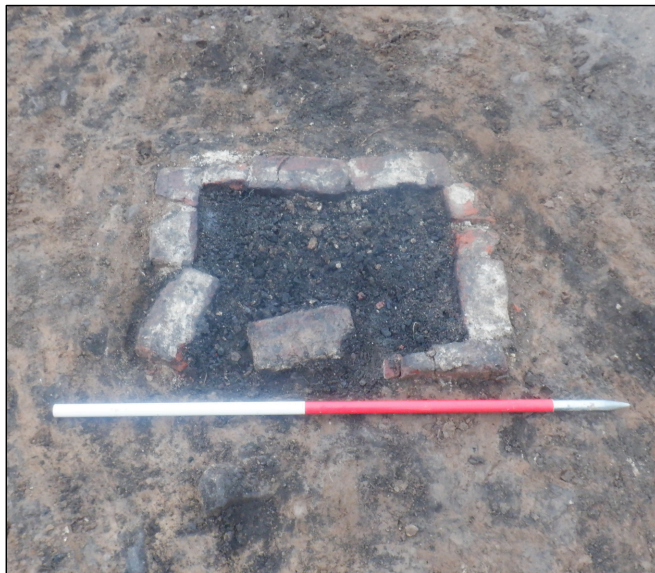
Plate 19: Ash pit 13050, looking west

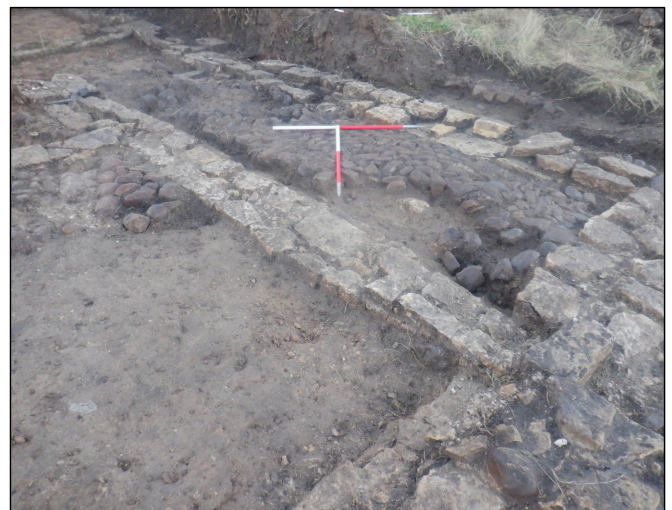
Plate 20: Passage 1, looking north-east

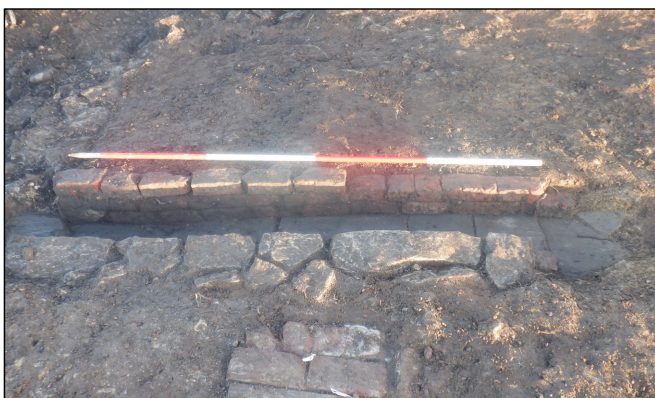
Plate 21: Culvert 13015, looking south

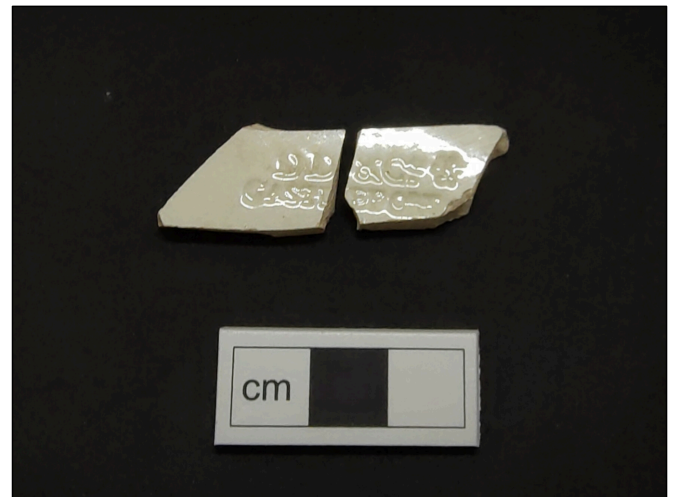
Plate 26: Context 13155, Creamware sherd with maker’s mark: David Dunderdale & Co. Castleford Pottery; c.1790 and c.1820

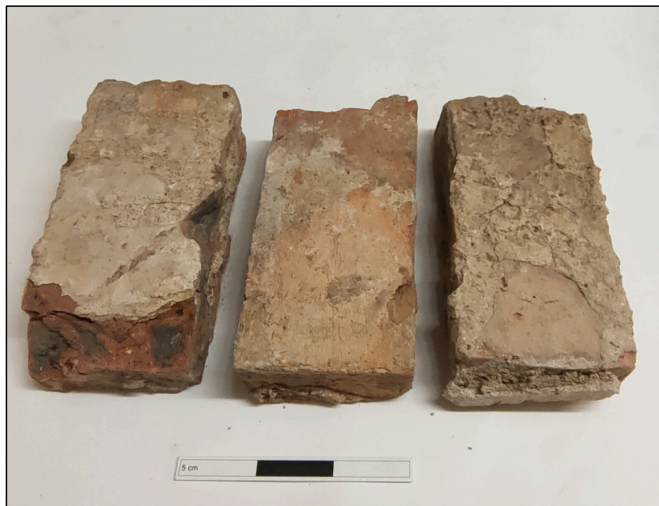
Plate 28: 17th to 18th-century brick from cellar vaulting 13030

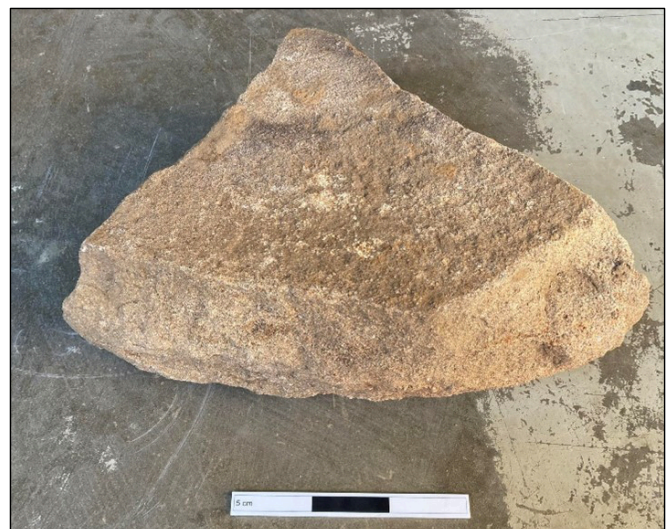
Plate 29: SF1 rotary quern

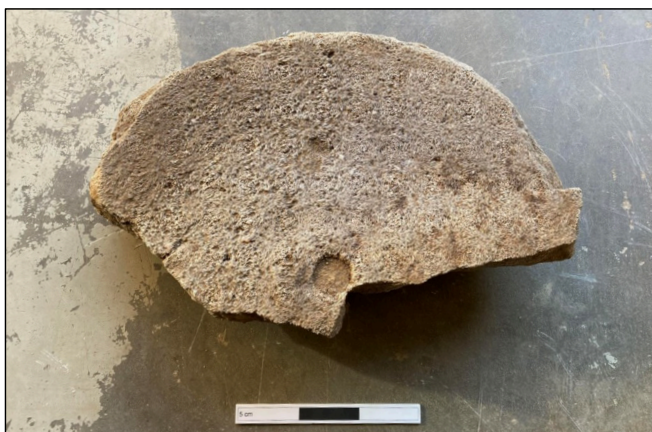
Plate 32: SF4 lower rotary quern fragment

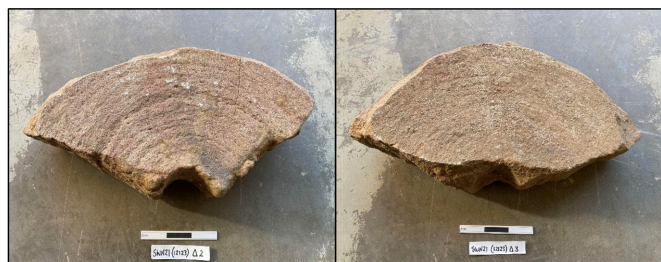
Plate 30: SF2 and SF3 worked face

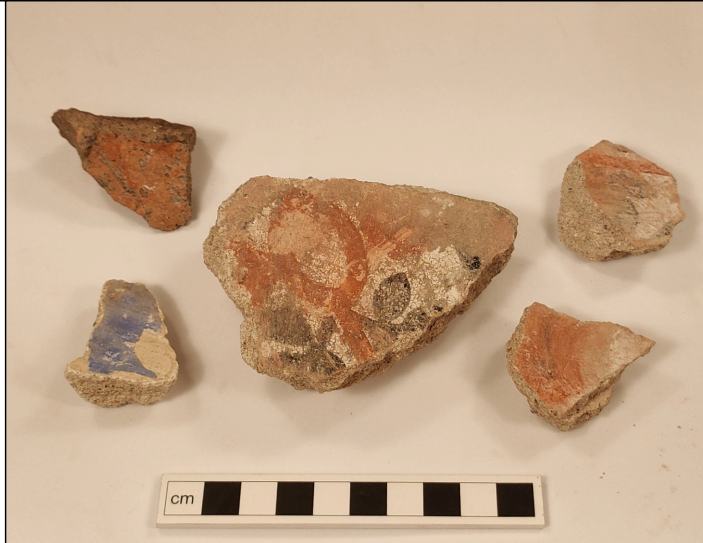
Plate 33: Fragments of wall plaster with painted decoration from cellar backfill deposit 13108

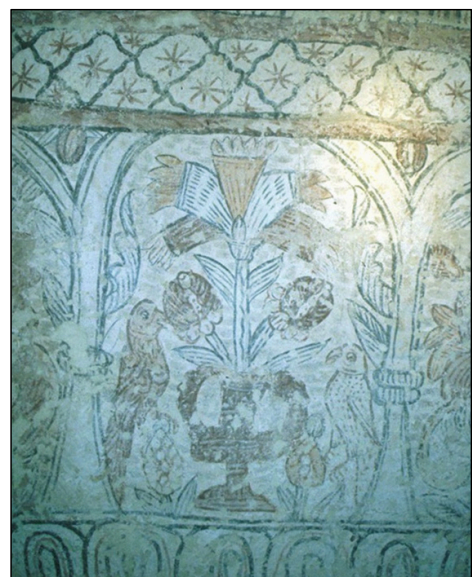
Plate 34: Example of painted plaster from Home Farm, Scriven, North Yorkshire

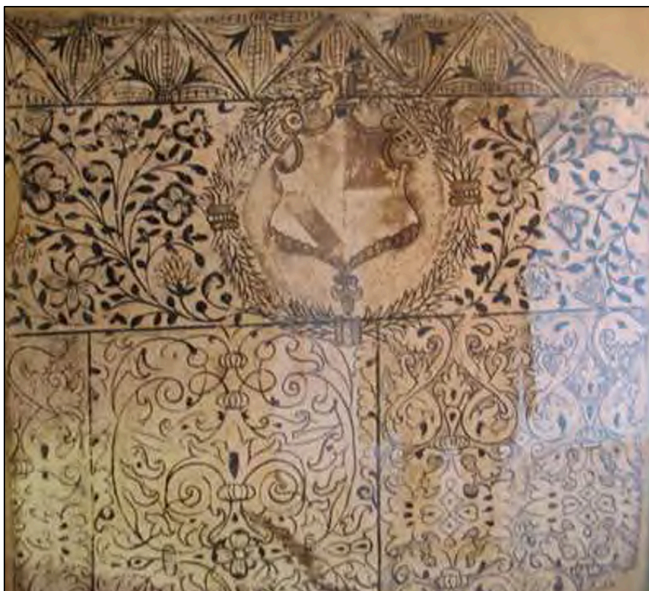
Plate 36: Painted plaster from Fittleworth Court now in the Weald and Downland Museum - pattern derived from blackwork embroidery

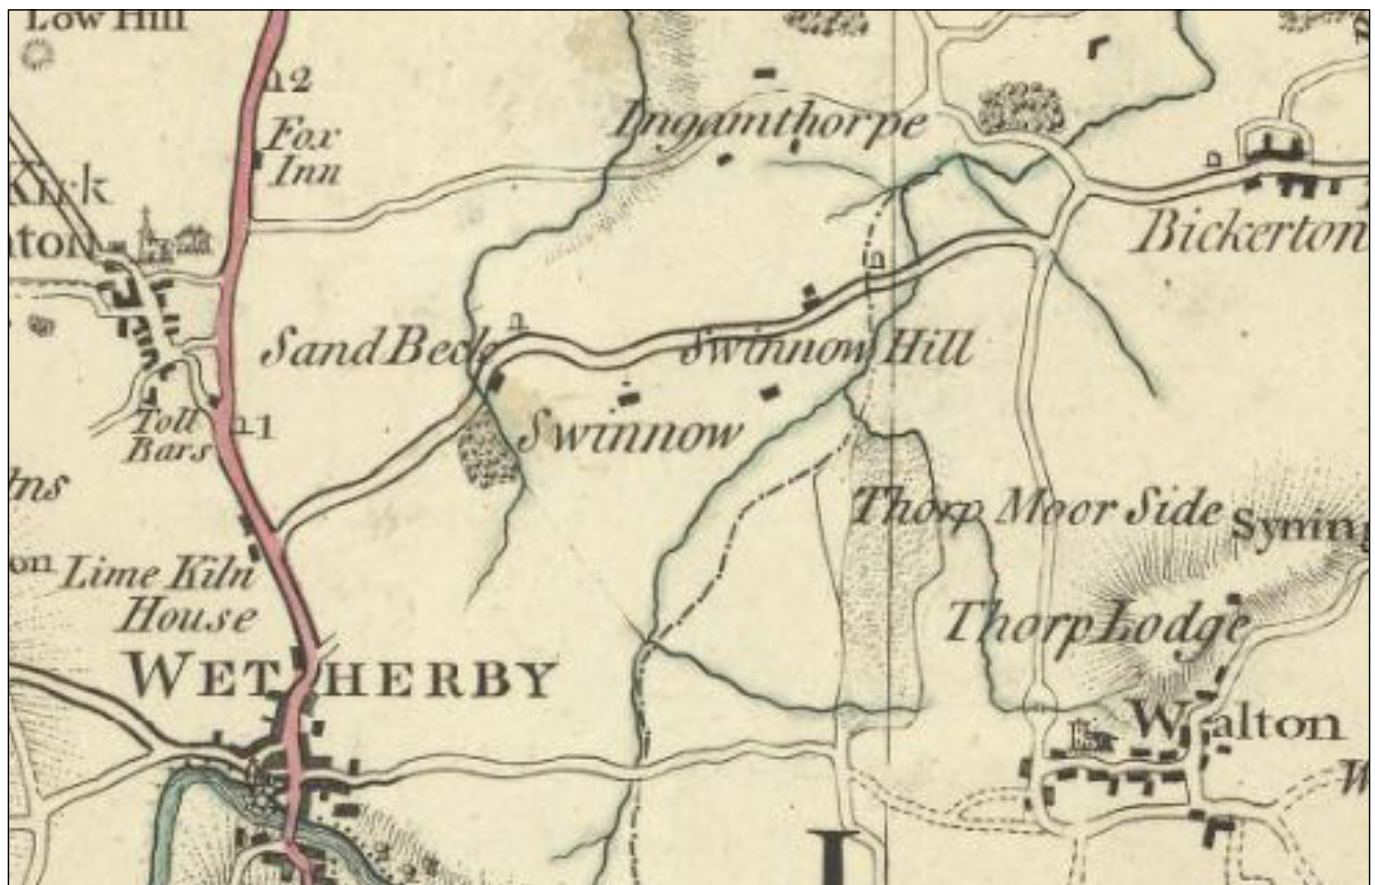
Figure 13: Extract from Jefferys' map of Yorkshire, 1771
